The car we'll be working with is an early C3, but a lot of these concepts transcend generations. Pat Hendrix, CM's faithful consultant from Precision Motive in Hayward, California, took some time off to guide me down the same comprehensive checklist that he uses when asked to inspect one of these cars in his own Corvette shop (*photo 1*).

Looking for Mr. Goodcar

What do experienced eyes look at during a pre-purchase inspection?
Jeff Glenn learns how the pros do the job on an early C3.

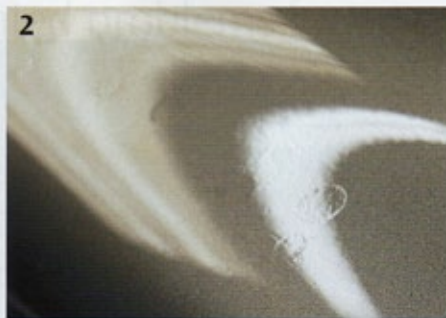
weren't visible in regular sunlight, including two spots on the side of the hood blister probably caused by drips from the painter's spray gun (*photo 2*). They'd been properly buffed and levelled, so they wouldn't be an issue on any kind of street car. For a top-level showcar, it would've been more of a problem.

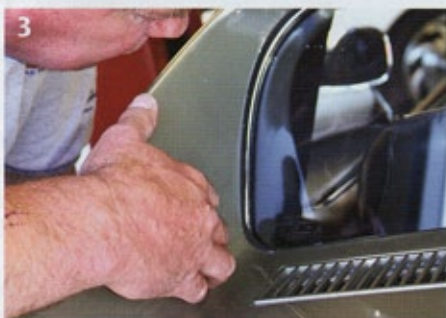
C: Another spot that's notoriously tricky to paint on early C3 coupes is the curved area around the backlight (*photo 3*). In respays this section is frequently missed, so it ends up feeling dimply and rough.

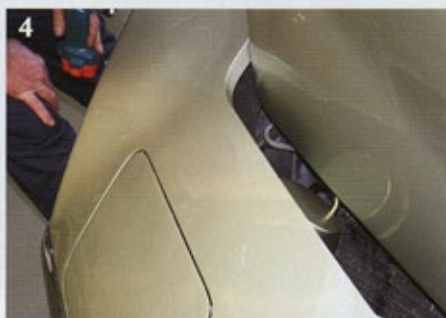
At the nose, look for signs of rivets just in front of the leading edge of the hood; there's a steel header bar under there, and imperfect repairs often let the rivet heads show through (*photo 4*). The same rivets are also susceptible to rust, which shows up as cracks or subsurface dimpling. Pat found evidence of slight patchwork on one front corner, but felt that "Unless this was represented as a 100-point showcar, I wouldn't be alarmed by anything that minor."

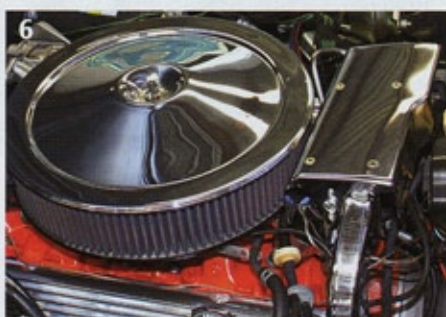
E: Upon popping the hood, Pat pointed out a cockeyed distributor shield (*photo 6*). "Very common; it's easy to mix up the brackets that bolt to the manifold, and putting one on the first time is always trial-and-error." He took

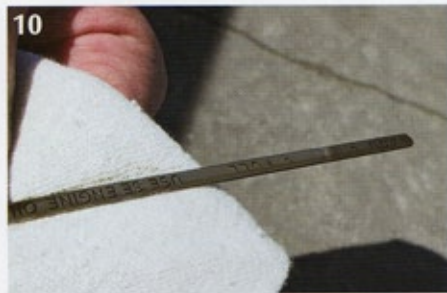
G: Moving along under the hood, he pulled out the dipstick *without wiping it* and held it up in the sun to assess the oil—whether it was dirty, clean, or (in this case) even there at all (*photo 10*). With no fluid on the stick, this car was a minimum of two quarts low. Two quarts later, the level in this engine was right on the money, and what was already in there seemed clean. "I always check that because later, out on a test drive, I'd have the throttle on the floor and not enough oil in the sump." Pat made a mental note to check for any indication of oil-burning or leakage later in the inspection—as it happened, he didn't find any.

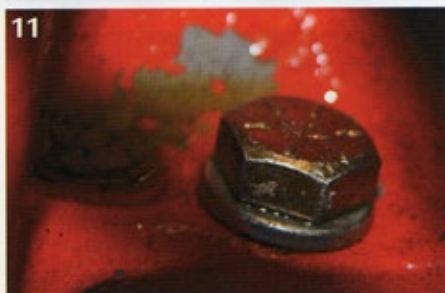
H: Looking around the intake manifold for puddles of anything that shouldn't be there, he noticed a blob of coolant in a crevice near the thermostat housing (*photo 11*). From the location, Pat felt it was probably due to a seeping thermostat housing or an imperfect heater hose; in either case, a very minor fix.

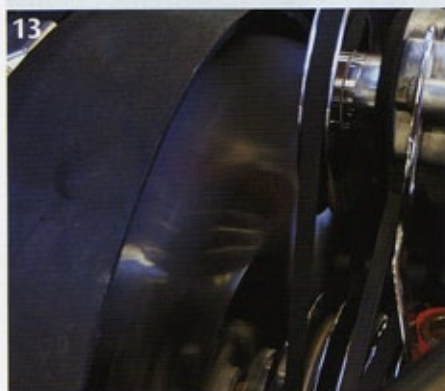
K: During the brief warmup and cranking test, Hendrix observed that the fan kept spinning long after the engine was stopped (*photo 13*). "That means that the fan clutch isn't working well; we'll have to keep an eye on the temp on the test drive."

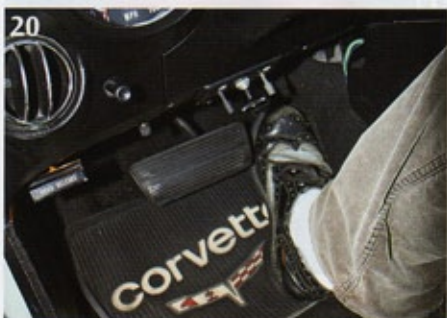
Pat's final underhood check again required a helper. He pulled the aircleaner off and, after looking at the carb for leaks or staining, had me mash the pedal to the floor (*photo 20*) with the engine off as he watched. He was checking to see that the butterflies were fully opening—which they weren't. The primaries were barely reaching half-throttle, in fact, and the secondaries were not even moving. This could require a simple adjustment to fix, or mean a reworking of the entire linkage system. It's also a good idea to verify that a nicely atomized shot of fuel gets delivered as you manually snap open the throttle linkage.

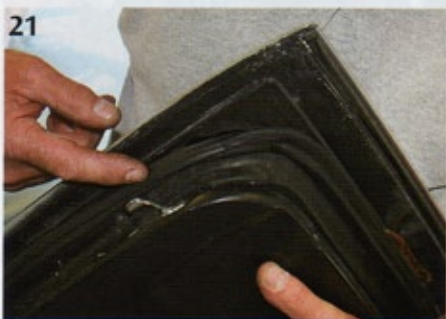
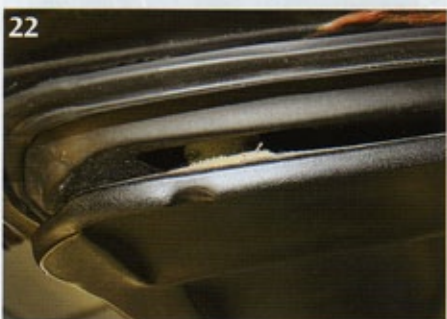
Q: Before getting deep into the interior, Pat popped off the T-tops to check their weather seals and headliners. "Two things happen to these: The weatherstrips get folded over on the inside lip (*photo 21*), and the headliners get loose and start hanging down (*photo 22*)." Droopy headliners are difficult to set right, and as long as they don't bug the driver they're best left alone. A damaged weatherstrip, on the other hand, is easy to repair and can lead to costly leaks. (Sometimes, you can get the rubber to shift back into the proper location by putting the T-top back on while using a thin piece of cardboard as sort of shoe-horn. After the T-top is locked in, just slip out the cardboard and go.) Some of the most expensive C3

repairs involve rust in the substructures of the windshield and greenhouse. Leaky T-top seals are one of the biggest causes of that condition, so a thorough inspection of both the seals and the steel parts below is a must.

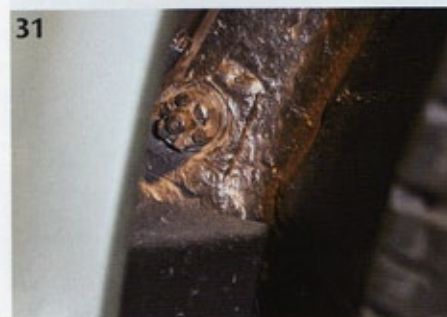
side yokes from sliding off, and a lot of side load passes through these attachments. There are two different styles, a heavy-duty yoke threaded for a bolt and cap (*photo 30*), and a standard yoke with a strap and a nut. This car had the heavy version, which was a common upgrade in the 1970s. ("I don't want to say the standard ones weren't heat-treated properly at the factory," Pat offered, "but the ends certainly tended to wear off. From about '76 to '79 we did hundreds of rear ends.") If this assembly becomes worn you can feel play at the rear wheel—it's easy to mistake this for a bad wheel bearing. Also make sure to look at the cotter pins on the trailing-arm bolts; our '72 was missing one (*photo 31*).

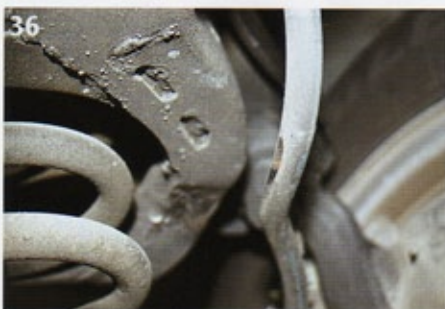
Up front, Pat looked to see if the soft lines were properly oriented and not scraping the frame. Sure enough, he found that the right-front line was twisted and had rubbed the paint off in one area. The same problem had abraded a fair amount of the rubber off the line (*photo 36*). After that, eyeballing the pads and rotors revealed no worrying issues; neither did grabbing the front wheels and shaking them to assess the bearings (*photo 37*). Pat then spun each tire in turn to reveal cupping, wobbling, or other signs of trouble. He also felt across the tread of each tire; when I asked him why, he explained that if the surface feels rougher in one direction than the other, it's often a sign of improper toe.
