The car we'll be working with is an early C3, but a lot of these concepts transcend generations. Pat Hendrix, CM's faithful consultant from Precision Motive in Hayward, California, took some time off to guide me down the same comprehensive checklist that he uses when asked to inspect one of these cars in his own Corvette shop (*photo 1*).

Looking for Mr. Goodcar

What do experienced eyes look at during a pre-purchase inspection?
Jeff Glenn learns how the pros do the job on an early C3.

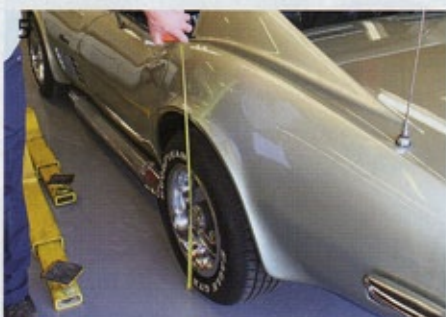
D: Scoping out the car's stance, Pat said "It's maybe a bit high in the back, probably thanks to heavy-duty springs." After checking the tire pressures to be sure they were even, he took out a tape measure and verified the distance from the ground to each fender lip (*photo 5*)—a surefire way to detect tired springs. The car sat a tad lower on the driver's side than the passenger's side—not unusual given less-than-brand-new springs—but it was close enough.

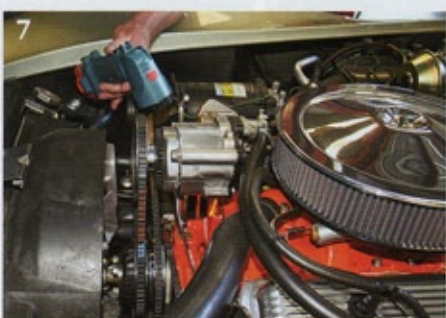
At the front of the engine, the next revealing inspection involved belt alignment. First Pat checked the clearance between the lower radiator hose and the drive belt. Chevy used a bracket to act as a shield here, but on a neglected car the belt often works free and starts cutting the hose. "These cars are also notorious for having the air-pump and power-steering pumps askew—I'm constantly modifying the brackets to get them straight. On this car, the alignment (*photo 7*) is fantastic."

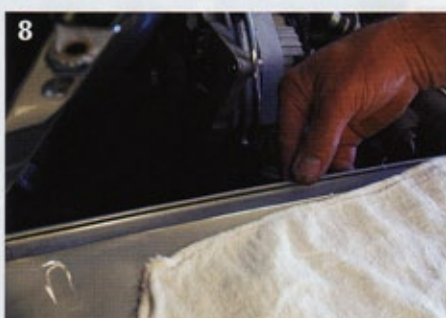
The engine-compartment lip was checked for damage or cracking next (*photo 8*), especially at the junction where it meets the fender. Cars that have been hit can show signs of hasty repairs in these areas. If the surfaces are smooth and you don't find anything rough or bumpy, it's okay to move on.

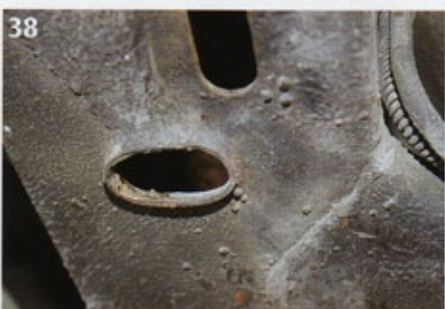
car has led. Of course rust and accident damage are the main issues, but less obvious signs can tell stories, too. At the rear of the C3 one finds a couple of oblong frame holes (photo 38) that tow-truck drivers love hooking into; often that bends the holes open toward the back of the car. If the same holes are bent out toward the front, it may mean the frame has been straightened on a hydraulic crash-repair jig. Similarly, loose bolts at the power-steering ram can eventually rip out of the frame and cause odd steering behaviors. And the bottom surface of the front crossmember (photo 39) often has big, scooped-out dents due to overzealous use of a floor jack. While not mechanically hazardous, these dents do say a lot about the people who maintained the car.
